US Army Corps  
of Engineers  
Waterways Experiment  
Station

Miscellaneous Paper SL-95-3  
July 1995

# Diamond-Coated Versus Conventional Bits for Rotary Cutter Head Equipment

Final report

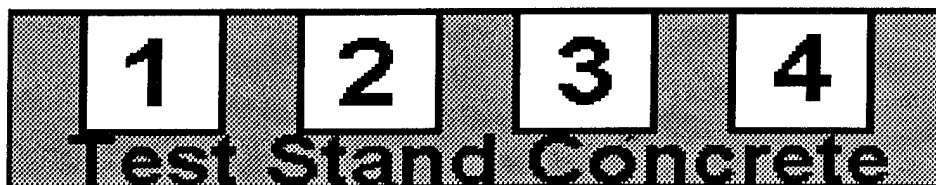
Test stand 1 (Figure 4) contained four 1.2-m-wide by 1.2-m-high by 2.4-m-long (4-ft-wide by 4-ft-high by 8-ft-long) mass concrete test specimens. The first and fourth specimens in the test stand contained mixture 1 concrete; the second and third specimens, mixture 2. The test stand concrete that separated the mass concrete test specimens was also removed, and the rates were recorded.

Figure 4. Locations of mass concrete test specimens within test stand 1
